# **Major Rehabilitation Evaluation Report**

## Columbia River at the Mouth, Oregon and Washington

# Major Rehabilitation of the Jetty System at the Mouth of the Columbia River

June 2012 Final

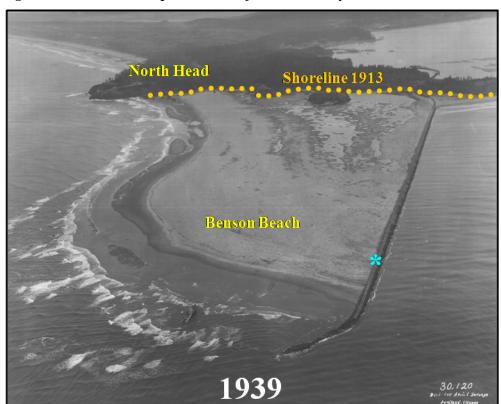
Figure 1-6. Shoreline Response North of the North Jetty

Beaches on the ocean sides of the North and South jetties, which formed as a result of jetty construction, have been receding gradually over the years, exposing previously protected jetty sections at the beach line to storm waves (Figure 1-6 shows Benson Beach recession at the North Jetty). This recession is in direct proportion with jetty length. As jetty length is shortened, beach front is lost.

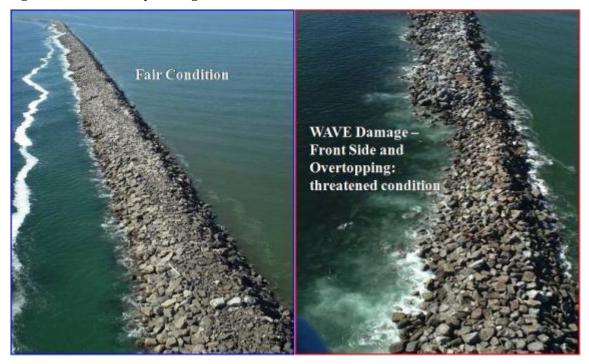
Figure 1-8. South Jetty Damage Areas

Despite intermittent repair and partial rehabilitation efforts, all of the MCR jetties are currently in a significantly deteriorated condition (Figure 1-8 and Figure 1-9). Intermittent repairs were conducted in 2005 on the North Jetty and in 2006 and 2007 on the South Jetty. The last partial rehabilitation on the North Jetty was conducted in 1964 and addressed 17% of its length, on the South Jetty was conducted in 1982 and addressed 25% of its length, and on Jetty A was conducted in 1961 and addressed 56% of its length. The jetty heads of the North and South jetties have not been repaired since their original construction and are severely deteriorated. The South Jetty head is no longer connected to the trunk by a continuous above water jetty reach. The jetty heads continue to recede landward from their original locations. The above water lengths for the South and North jetties and Jetty A are currently shorter than their authorized lengths by 6,200 feet, 2,120 feet, and 900 feet, respectively. Due to the interaction of wave patterns and currents with the jetty configuration, the shorter jetty lengths can increase underwater shoal erosion, influence shoreline position adjacent to the jetties, and can increase the loading on the structures landward of the jetty head.

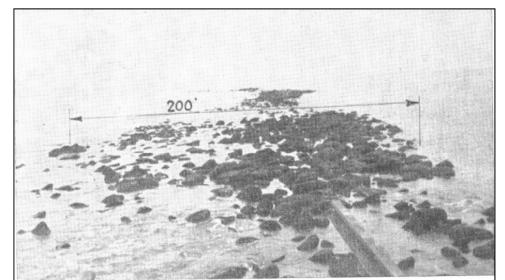
Figure 1-19. South Jetty Deterioration in 1930s

Mouth of Columbia River, Oregon; south jetty; old enrockment 21/2 miles west of Clatsop Spit; rock in place at least 21 years; July, 1934. 200' wide on top.

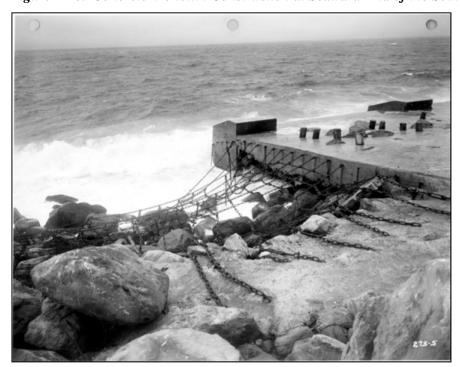
Figure 1-20. Concrete Monolith Construction at Seaward End of the South Jetty

During rehabilitation of the South Jetty in the 1930s, a 500-feet-long concrete cap was constructed to secure the jetty head at station 330. The seaward most 200 feet of the concrete cap was composed of a solid core monolith. (Figure 1-20) This cap has served well since 1940; however, the entire cap has been severely damaged due to the harsh wave climate that exists 3 miles offshore and is progressively failing. This cap serves as an anchor to secure and protect the un-reinforced area of the South Jetty immediately inshore of the cap. When the cap fails completely (i.e., falls off the jetty crest), the jetty trunk adjacent to the cap will rapidly deteriorate due to relentless wave action.

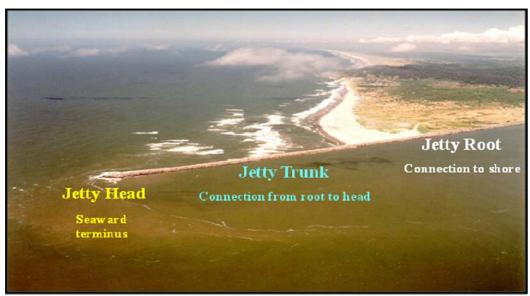
Figure 3-12. North Jetty, View to the North

General components of a coastal jetty and damage consequences. Jetty head recession leads to progressive loss of jetty function which can impact inlet dredging requirements and stability of other jetty areas. Cumulative jetty trunk damage can result in a trunk breach which can have functional consequences on the inlet. Cumulative jetty root damage can result in a root breach which can have serious functional consequences on the inlet. Note plume of suspended sediment transported past the jetty head and into the MCR inlet.

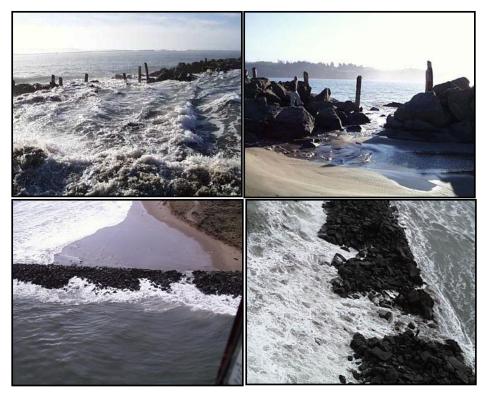
Figure A1- 249. Breached Jetty at Smaller Navigation Entrance

In some instances, a jetty segment may be damaged at such a high rate as to fail before timely repair can be implemented. A given jetty segment is assumed to lose function when the upper cross-section area has been reduced to less than  $15 \pm 5\%$  of the original standard upper cross-section. If a jetty segment fails within the body of the jetty, the segment is considered breached. If the breached segment was acting to retain the inlet's morphology, the failed segment may release a large volume of sand into the inlet which has the potential to impact MCR navigation. Figure A1- 249 and Figure A1- 250 show a breached jetty example at a smaller navigation entrance and the resulting adjacent shoreline sediment loss that resulted.

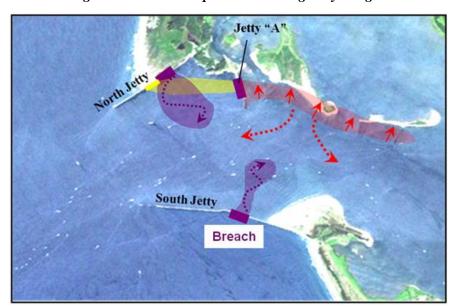
Figure A1- 253. Inlet Response to Jetty Breach

A jetty breach at MCR would establish flow through the jetty and destabilize adjacent morphology. Elevated shoaling within the MCR would occur. Aggressive dredging may be required to maintain the MCR channel, and the jetty may require emergency repair.

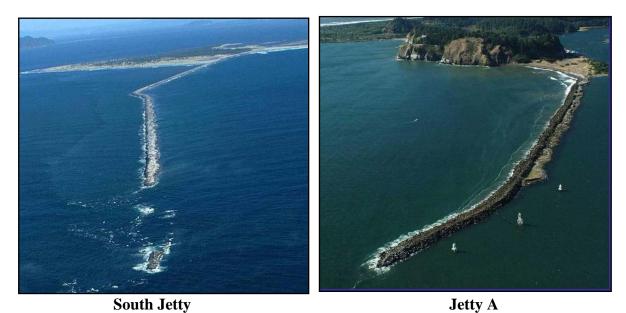
# Figure 2. Rubble-mound Jetties at the MCR

Top left photo shows the South Jetty looking east. The remnant feature shown disconnected from the primary structure is the concrete monolith that was constructed in 1941. The top right photo shows Jetty A. The bottom photo illustrates the North Jetty and the shoreline north of the MCR.

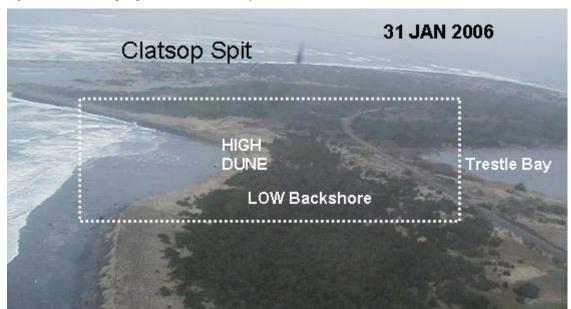
Figure 11. Clatsop Spit and South Jetty Root Erosion

Currently, the coastal shore interface along the South Jetty is in a condition of advanced deterioration. The foredune separating the ocean from the backshore is almost breached (Figure 11). The backshore is a narrow strip of a low-elevation, accretion area that separates Trestle Bay from the ocean by hundreds of yards. The offshore area along the South Jetty (and to the south) continues to erode, promoting larger wave action to affect the shoreline along the South Jetty root. The back-dune of Trestle Bay has continued to advance westward due to increased circulation in the bay, seasonal wave chop, and hydraulic surcharging.

Without foredune augmentation, the shoreline at the root of the South Jetty would continue to erode and recede, resulting in a possible shoreline breach into Trestle Bay in about 8-16 years. If this sand spit breach occurs, the result would be catastrophic. The MCR inlet would establish a secondary flow way from the estuary to the ocean along this area (south of the South Jetty). This condition would profoundly disrupt navigation at the MCR and bring lasting changes to the physical nature of the inlet.

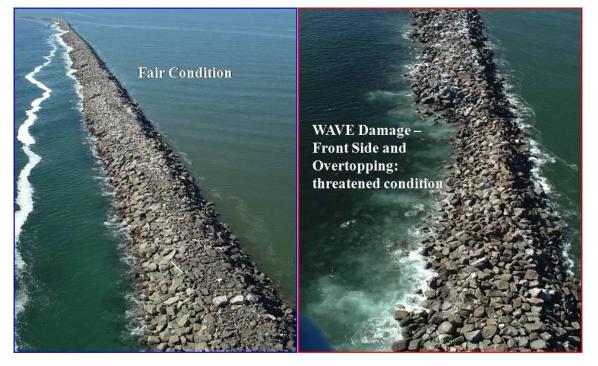
Figure 6. South Jetty Trunk Damage

Despite intermittent repair and partial rehabilitation efforts, all of the MCR jetties are currently in a significantly deteriorated condition (Figures 6 and 7). Intermittent repairs were conducted in 2005 on the North Jetty and in 2006 and 2007 on the South Jetty. The last partial rehabilitation on the North Jetty was conducted in 1964 and addressed 17% of its length; the last partial rehabilitation on the South Jetty was conducted in 1982 and addressed 25% of its length; and the last partial rehabilitation on Jetty A was conducted in 1961 and addressed 56% of its length. The lengths of the North and South jetties, which have never been repaired since original construction, are 55% and 36%, respectively. The jetties continue to recede back from their original length. The head positions for the South and North jetties and Jetty A are currently shorter than authorized lengths by 6,200 feet, 2,120 feet, and 900 feet, respectively. Due to the interaction of wave patterns and currents with the jetty configuration, the shorter jetty lengths can increase underwater shoal erosion, influence shoreline position adjacent to the jetties, and alter the forcing climate at the project.
